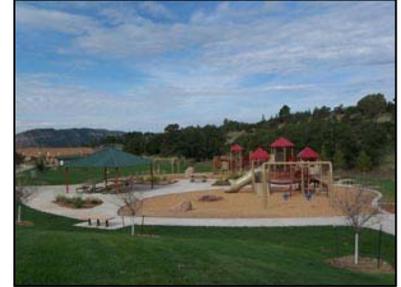
6.6.15 JENKINS RANCH PARK

- Playground equipment is un-shaded

- Shade shelter for playground

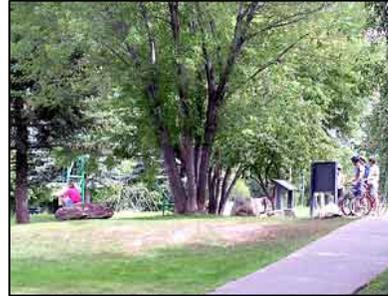
6.6.16 MEMORIAL PARK (PHASE 1)

- The site is frequently used as a river access point for both commercial and private boaters, but is not well configured for this use. The parking and restrooms are too small, as well as turf areas are heavily damaged from traffic associated with river users.
- Armoring and bank erosion protection measures are desperately needed to mitigate impacts from human traffic on the river’s edge at the river access point
- While irrigation is centrally controlled, the water quality for irrigation is poor and frequently causes clogs and back-ups in the system due to solids and silt
- Restrooms are small and heavily vandalized

- The pump station will increase both capital maintenance requirements, as well as staffing, tooling, and training requirements

- Collaborate with predominant users groups, residents, and Public Works Department to establish a master plan for this site that can include design aspects that better address the heavy usage from river traffic

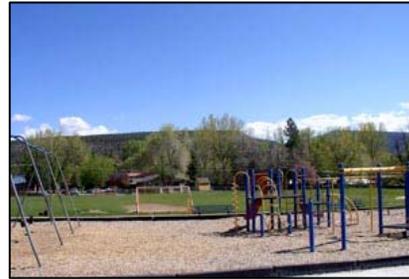
6.6.18 NEEDHAM ELEMENTARY PARK

- Playground equipment is owned and maintained by School District 9R

- Link irrigation system to central control

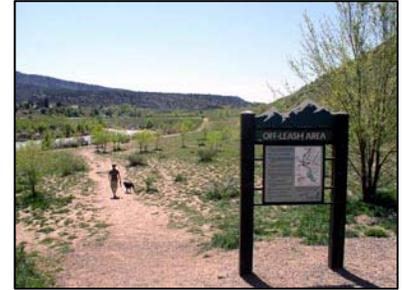
6.6.19 OFF-LEASH (DOG) AREA

- Park has limited parking for all weather access

- Complete plans for parking and pedestrian bridge
- Volunteer support for maintenance
- Landscape restoration with planting trees along the river corridor

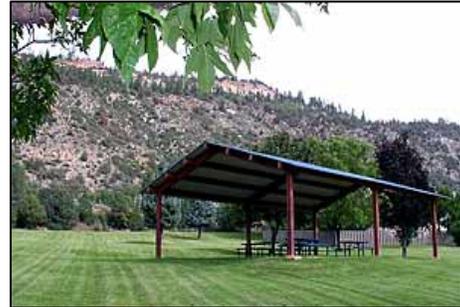
6.6.20 PIONEER PARK

- Irrigation system can be improved to add zones; north end of the park lacks sufficient irrigation to maintain the turf under heavy use

- Additional playground equipment, including tot lot equipment for younger children

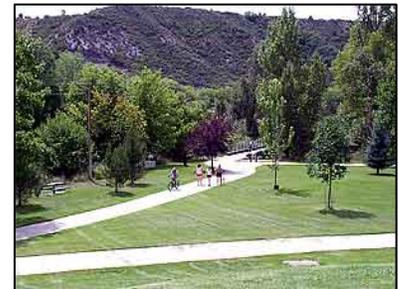
6.6.21 RANK PARK

- Irrigation system runs through Durango High School system, which creates coordination challenges at times
- Park experiences littering and vandalism from student use
- Park features two ground water springs which creates difficulties with turf maintenance in select areas
- Park structures include inoperable pump station

- Additional park amenities supporting youth usage of park
- Volunteer support for maintenance

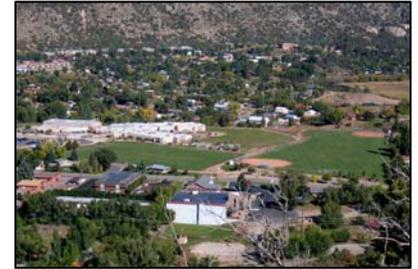
6.6.23 RIVERVIEW SPORTS COMPLEX

- Water quality for irrigation is poor and frequently causes clogs and back-ups in the system due to solids and silt. An expensive filter was required on the irrigation system to mitigate these challenges at this park.
- Spring use is a challenge due to ground saturation and turf protection issues
- Due to limited sports fields in town, this park is over utilized

- Future tot lot play equipment for younger children
- Update portable fencing to separate fields

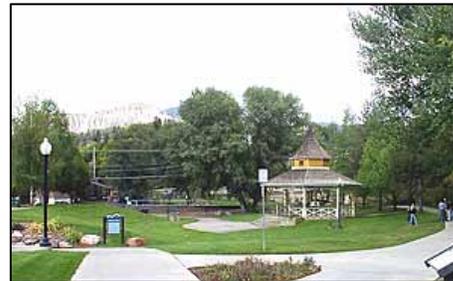
6.6.25 ROTARY PARK

- Unique construction of the gazebo increases the difficulty of the repairs. Repair is needed with roof
- Restrooms are heavily vandalized
- Water service in restrooms is undersized

- Repairs to gazebo
- Upgrade restroom
