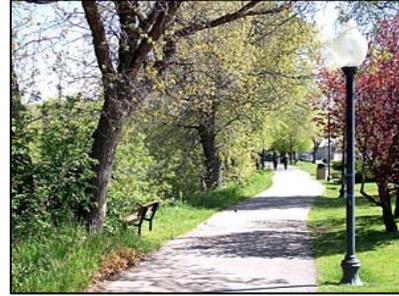
6.6.22 RIVERFRONT PARK

Park Asset / Amenity	Quantity	Condition
Picnic table	3	Good
Overlook bench	8	Good
Animas River Trail segment	Length of park	Excellent
Handicap accessible fishing pier	1	Excellent
Pedestrian bridge	1	Excellent
Grass turf area	1	Good
Handicap accessibility	n/a	Excellent

- Park is heavily used by the community
- Park provides aesthetic green space along Animas River near center of Durango and is included in the greenway
- Park provides nice fishing area near center of Durango that also features a handicap accessible fishing pier
- Irrigation is well functioning
- Turf is in good condition

- No challenges observed; the park is in excellent condition

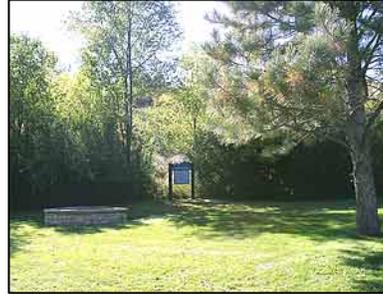
6.6.24 ROOSA PARK

Park Asset / Amenity	Quantity	Condition
Grass turf area	1	Excellent

- Park is used by the neighborhood
- Park is well shaded with mature trees
- Turf is in good condition
- Irrigation system is well functioning as a battery-powered, stand alone system

- No challenges observed; the park is in excellent condition
